PERFORMANCE DETERIORATION
DUE TO ACCEPTANCE TESTING AND FLIGHT LOADS
JT9D JET ENGINE DIAGNOSTICS PROGRAM

W. J. Olsson

UNITED TECHNOLOGIES CORPORATION
Pratt & Whitney Aircraft Group
Commercial Products Division

1. Report No. NASA CR-165572		2. Government Accession No.		3. Recipient's Catalog No.	
4. Title and Subtitle Performance Deterioration due to Acceptance Testing and Flight Loads; JT9D Jet Engine Diagnostic Program				5. Report Date January 22, 1982

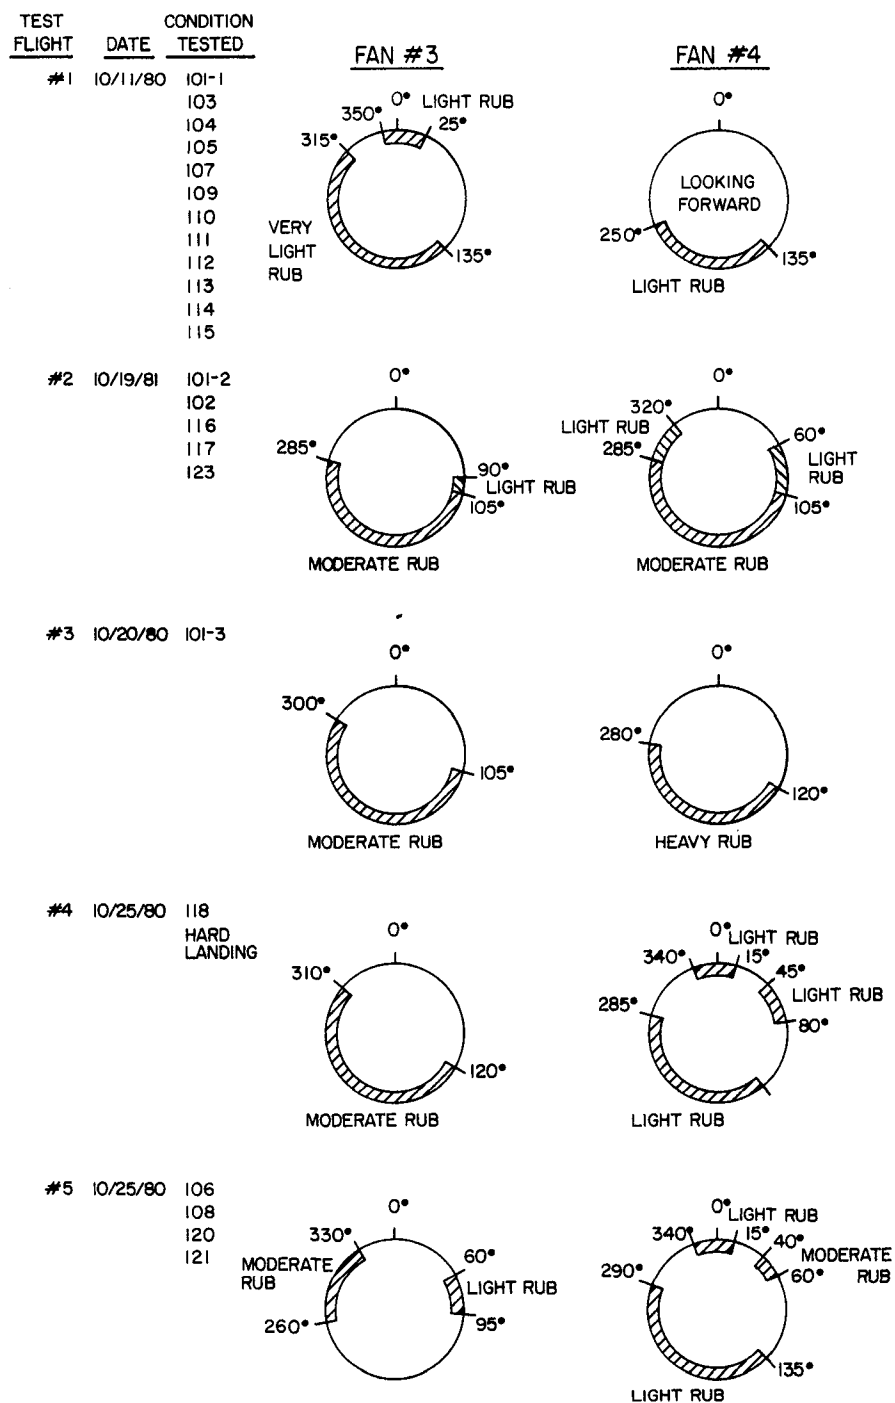
Figure 5-6 Post-Test Observation of Fan Rubs - Rub patterns for take-off tests are quite similar for the two test engines.

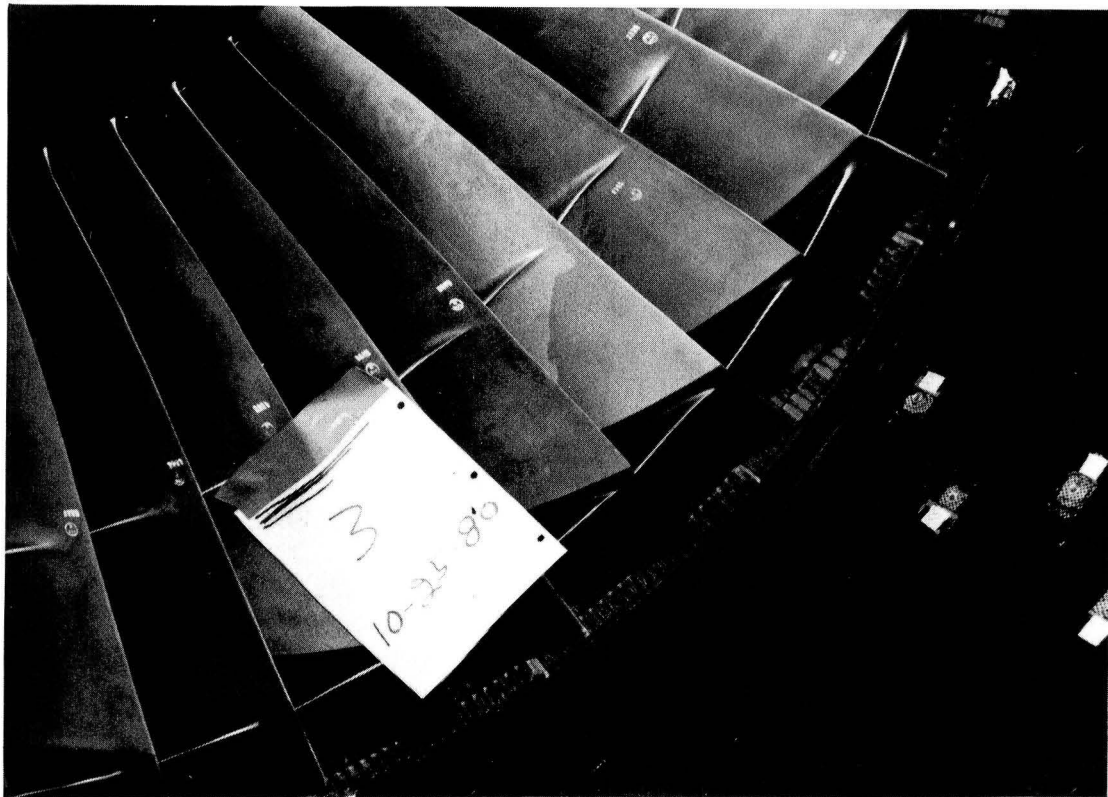
Figure 5-12 Visualization of Fan Rubs - Red dye sprayed on the fan outer air-seal shoes prior to each test flight permitted easy location of rubbed areas. (Boeing, FA-123468)

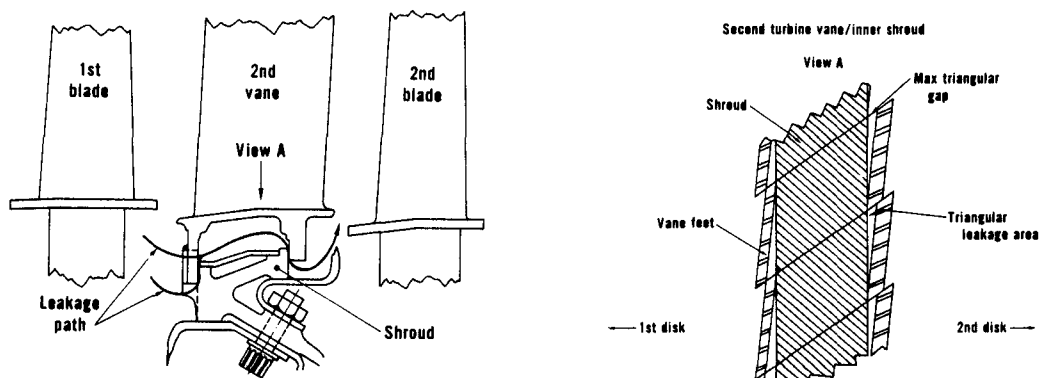
Figure 5-19 Configuration of High-Pressure Turbine Second-Stage Vane Assembly - Vane twisting causes leakage paths.

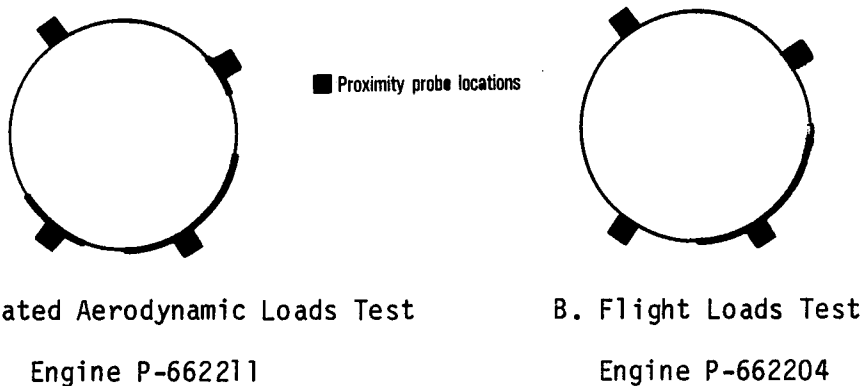
Figure 5-22 Comparison of Teardown Wear Patterns in the First-Stage High-Pressure Turbine Outer Air Seals (Rear View) - Both engines incurred rubs in the lower right quadrant.

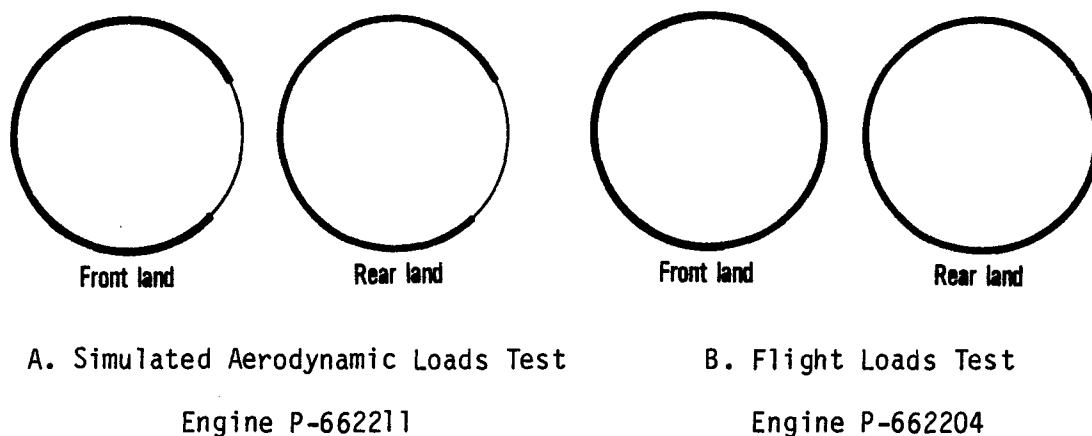
Figure 5-23 Comparison of Teardown Wear Patterns in the Second-Stage High-Pressure Turbine Outer Air Seals (Rear View) - The flight test engine incurred a full 360-degree rub while the rub was limited to 270 degrees on the simulated loads test engine.

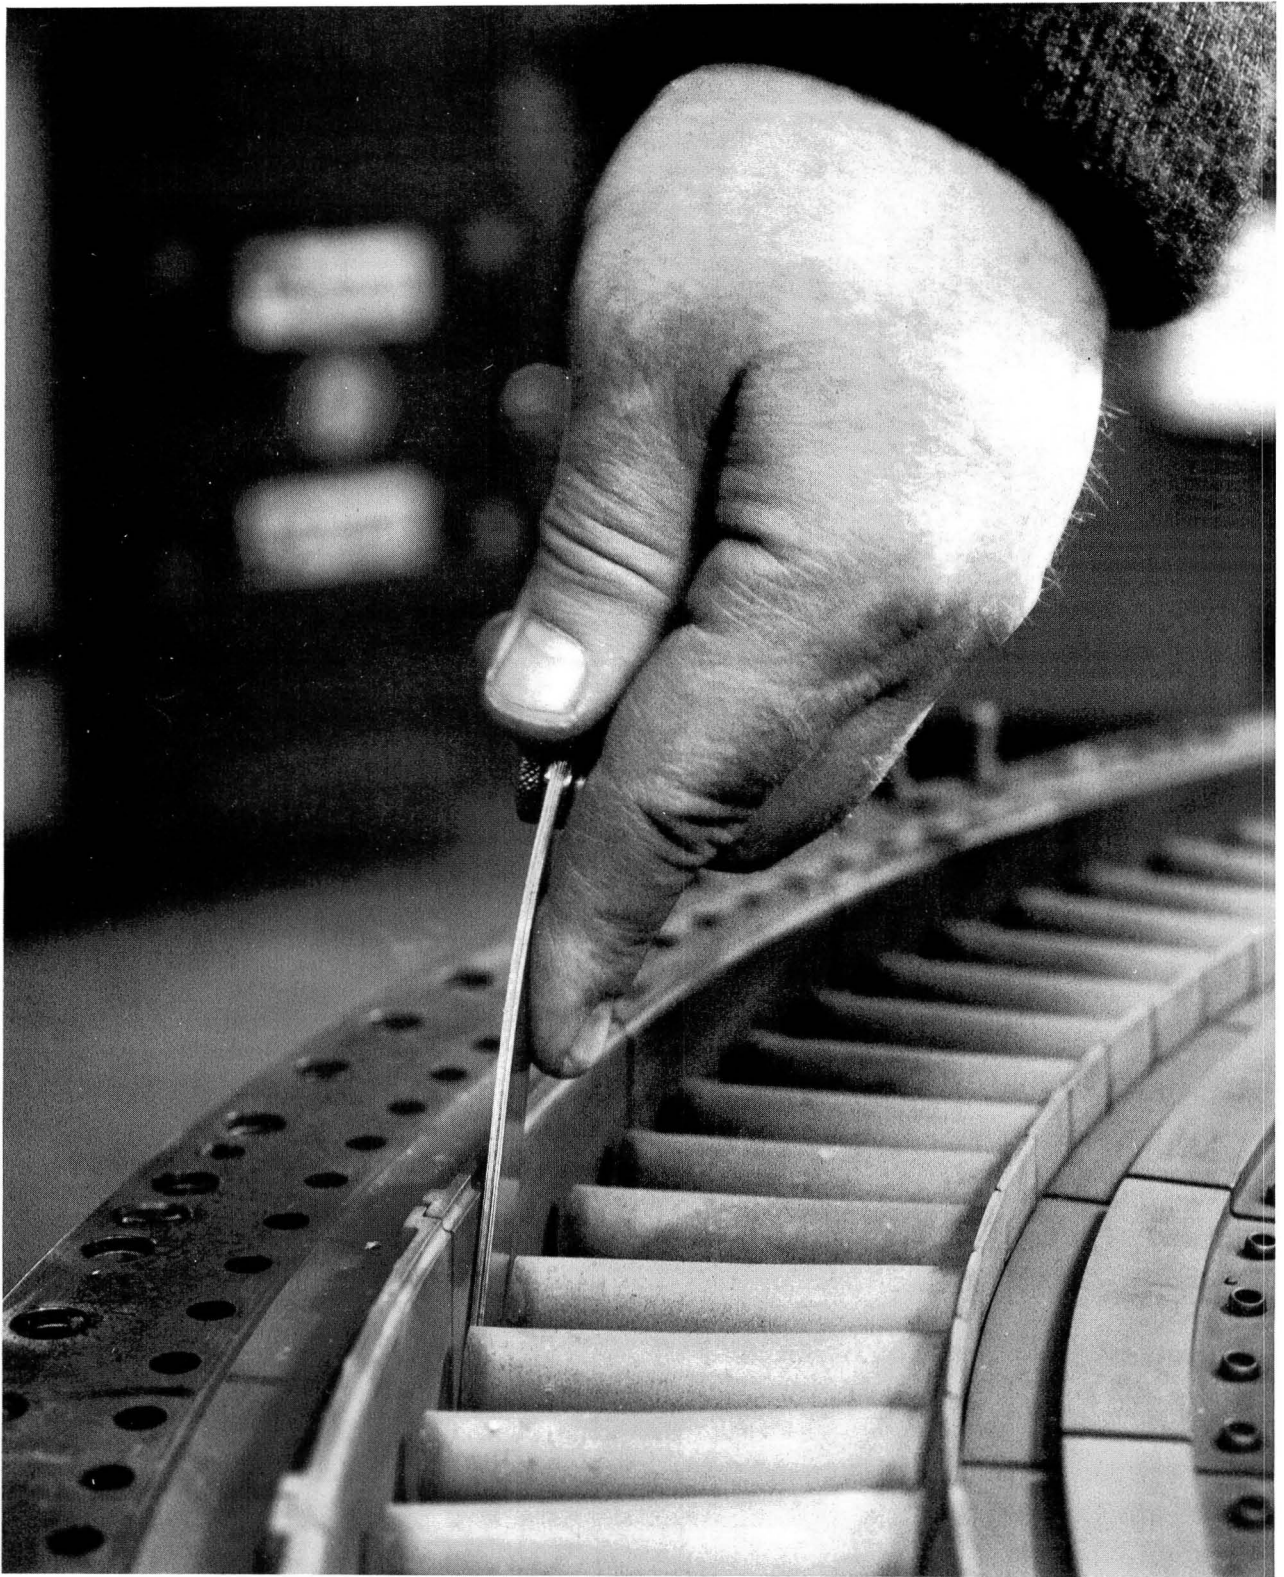
Blade Clearance Measurement During Disassembly of First-Stage High-Pressure Turbine. (81C-114-4)

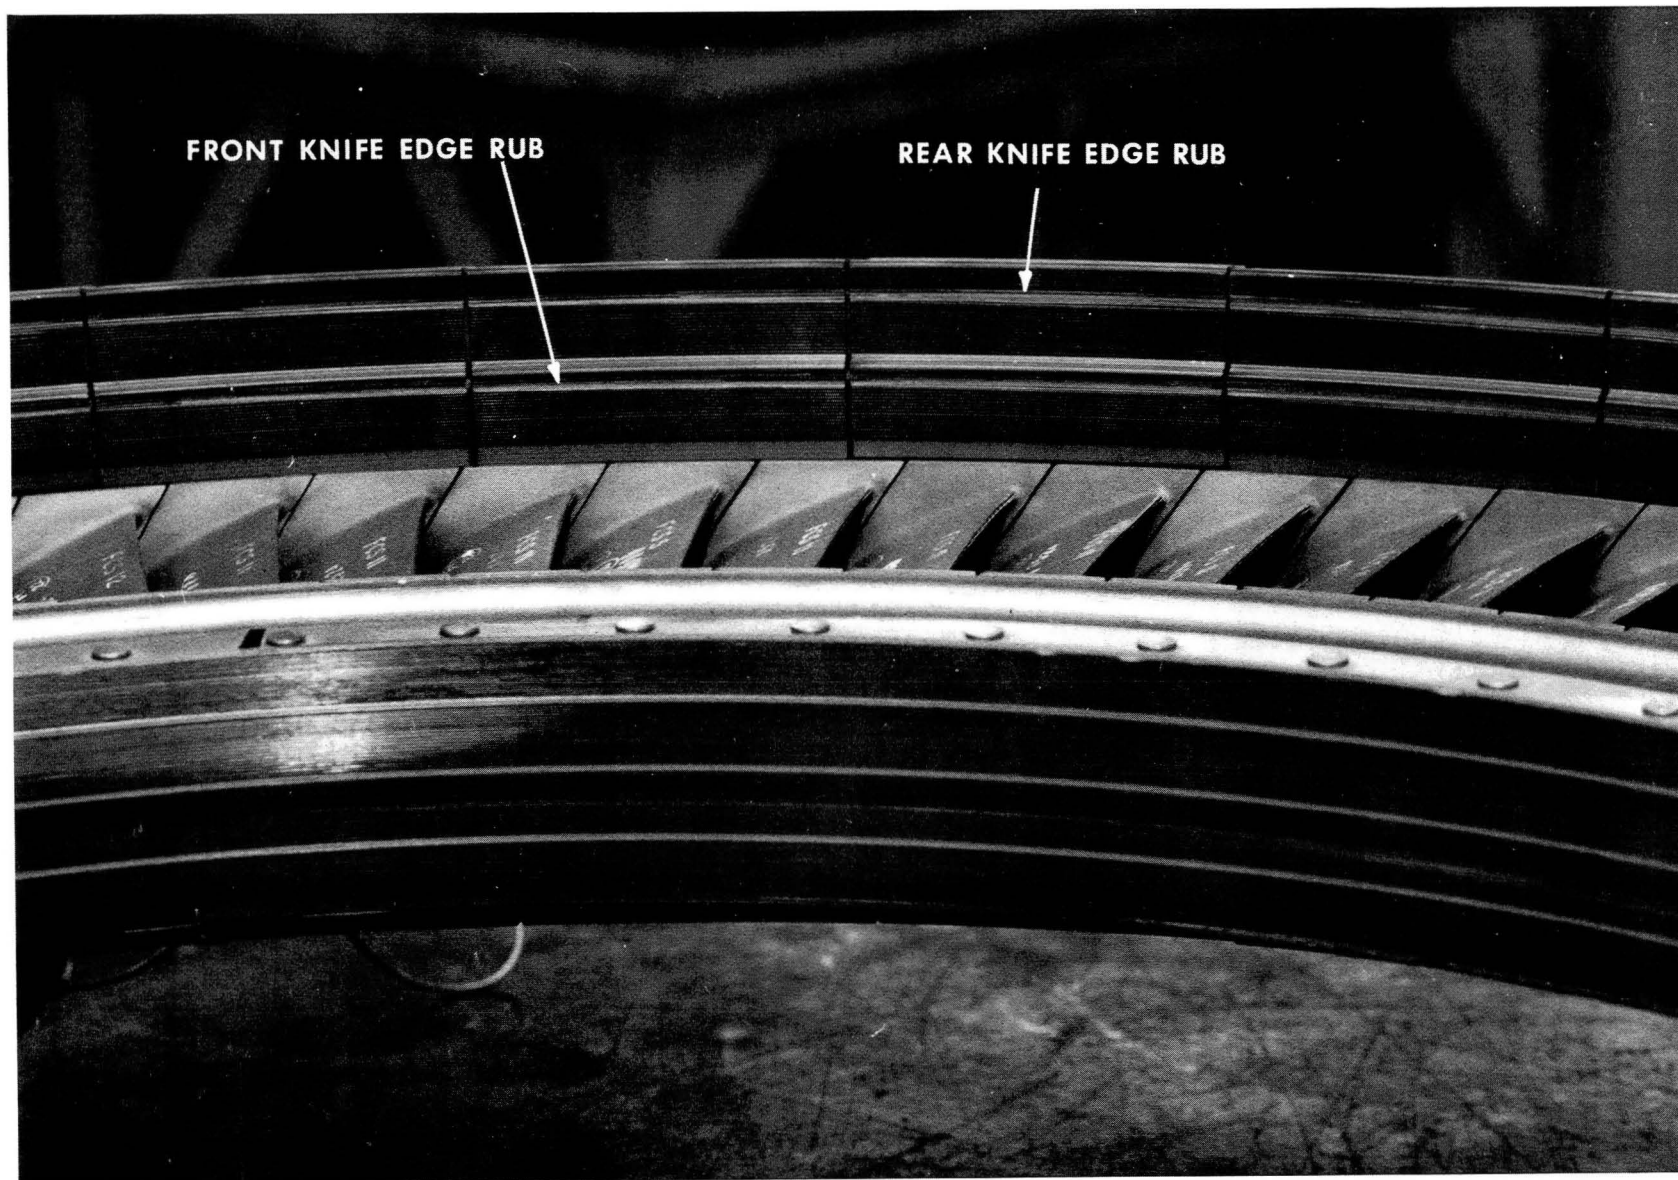
Second-Stage High-Pressure Turbine Outer Air Seal Assembly After Test Program.
(81C-153-1)

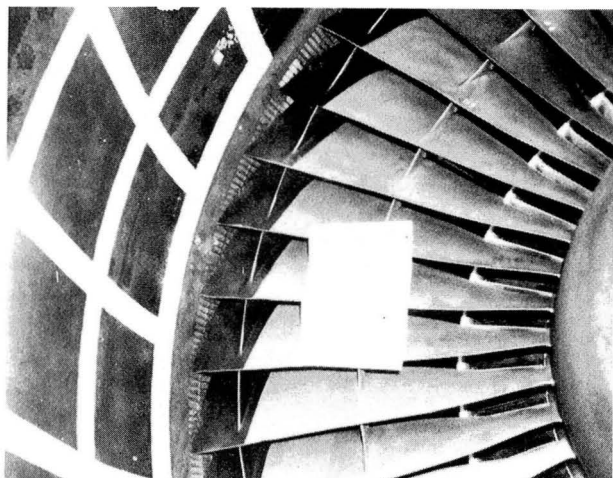
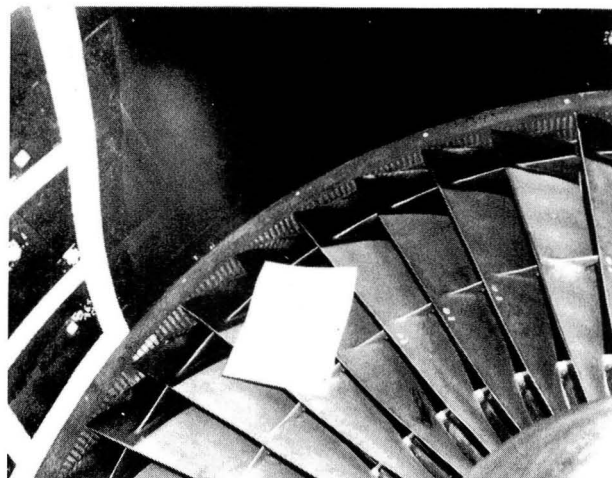
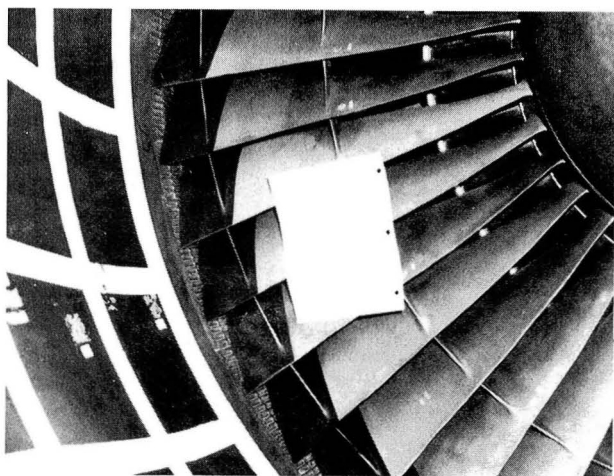
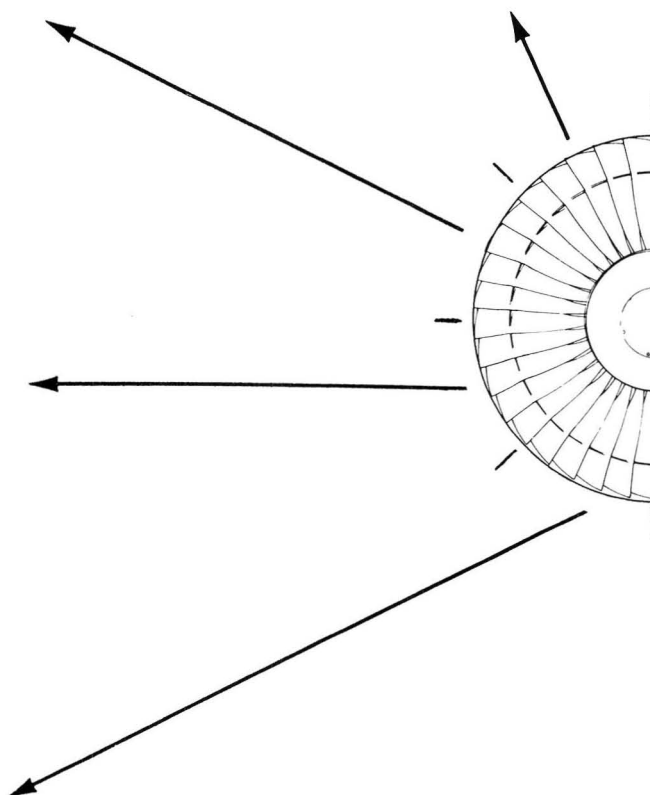
Fan Rub-Strip Wear on Position 3 Engine After Second Test Flight at 538,000-pound Take-Off Gross Weight with Flaps at 10 degrees; Left-Hand Portions. (Boeing, FA 123727 through FA 123730)

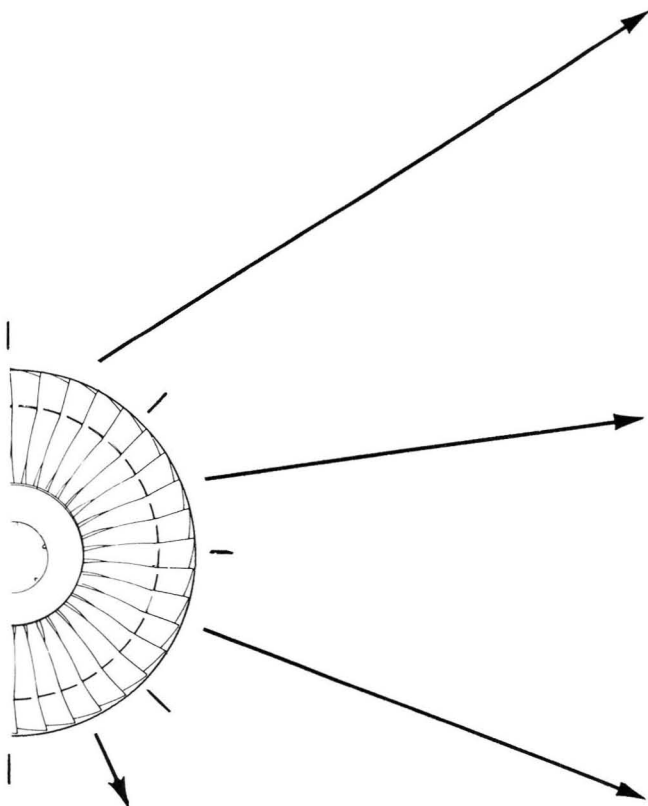
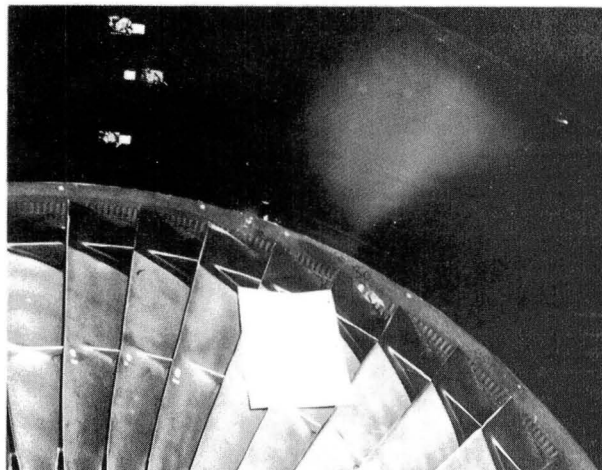
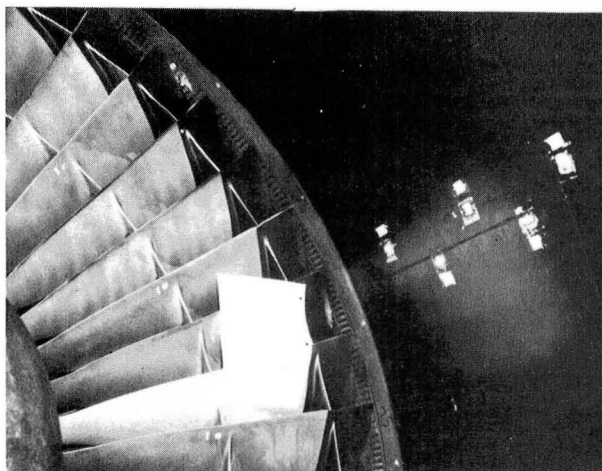
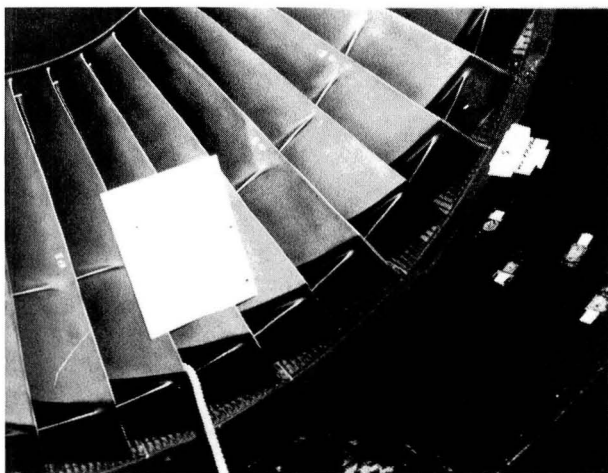
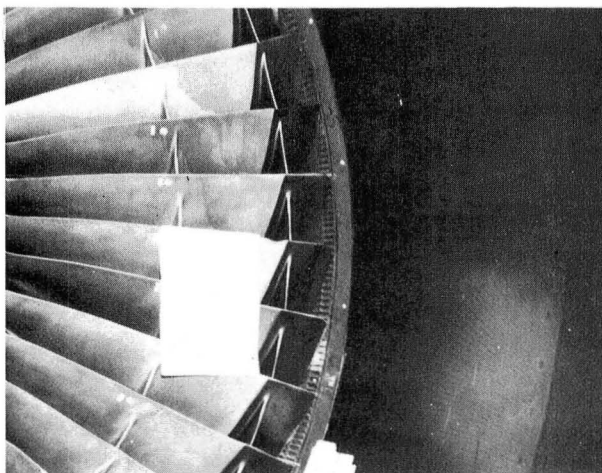
Fan Rub-Strip Wear on Position 3 Engine After Second Test Flight at 538,000-pound Take-Off Gross Weight with Flaps at 10 degrees; Right-Hand Portions. (Boeing, FA 123731 through FA 123734)

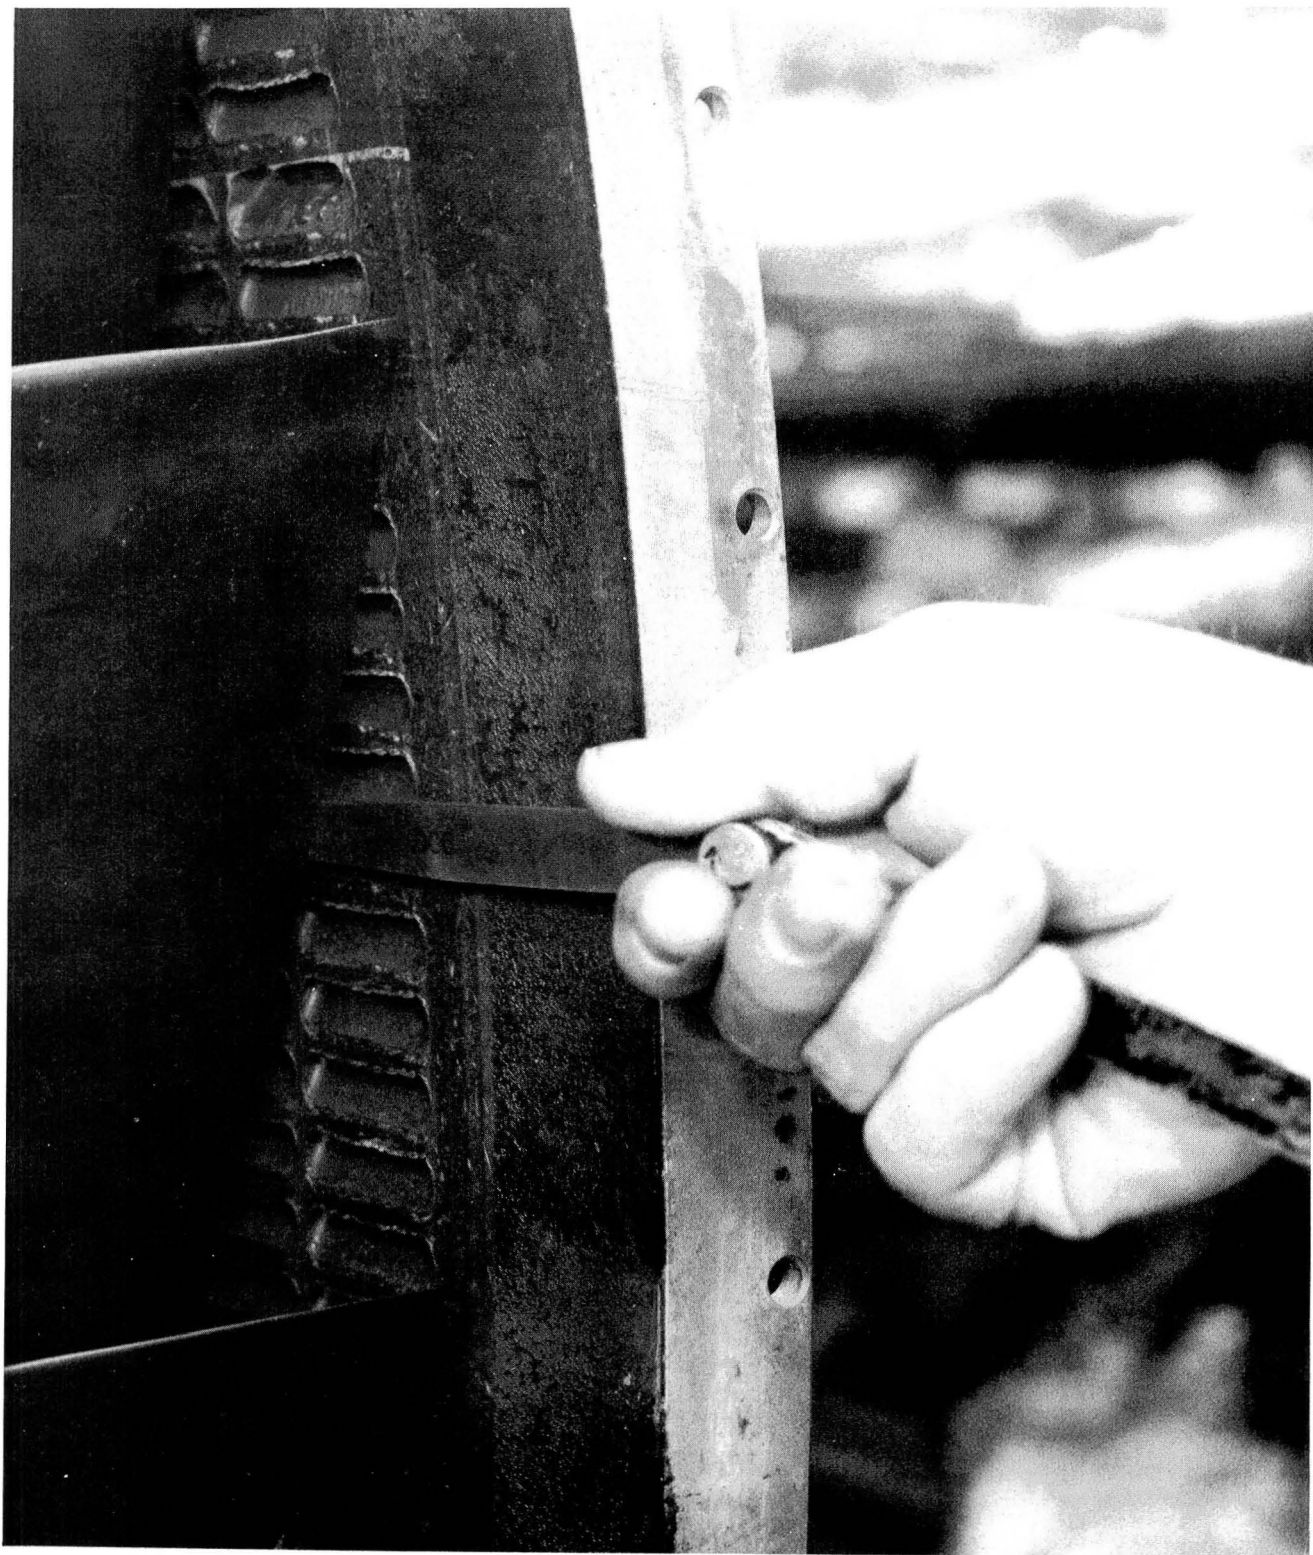
Fan Blade Clearance Measurement on Position 3 Engine After Test Program.
(81C-114-2)

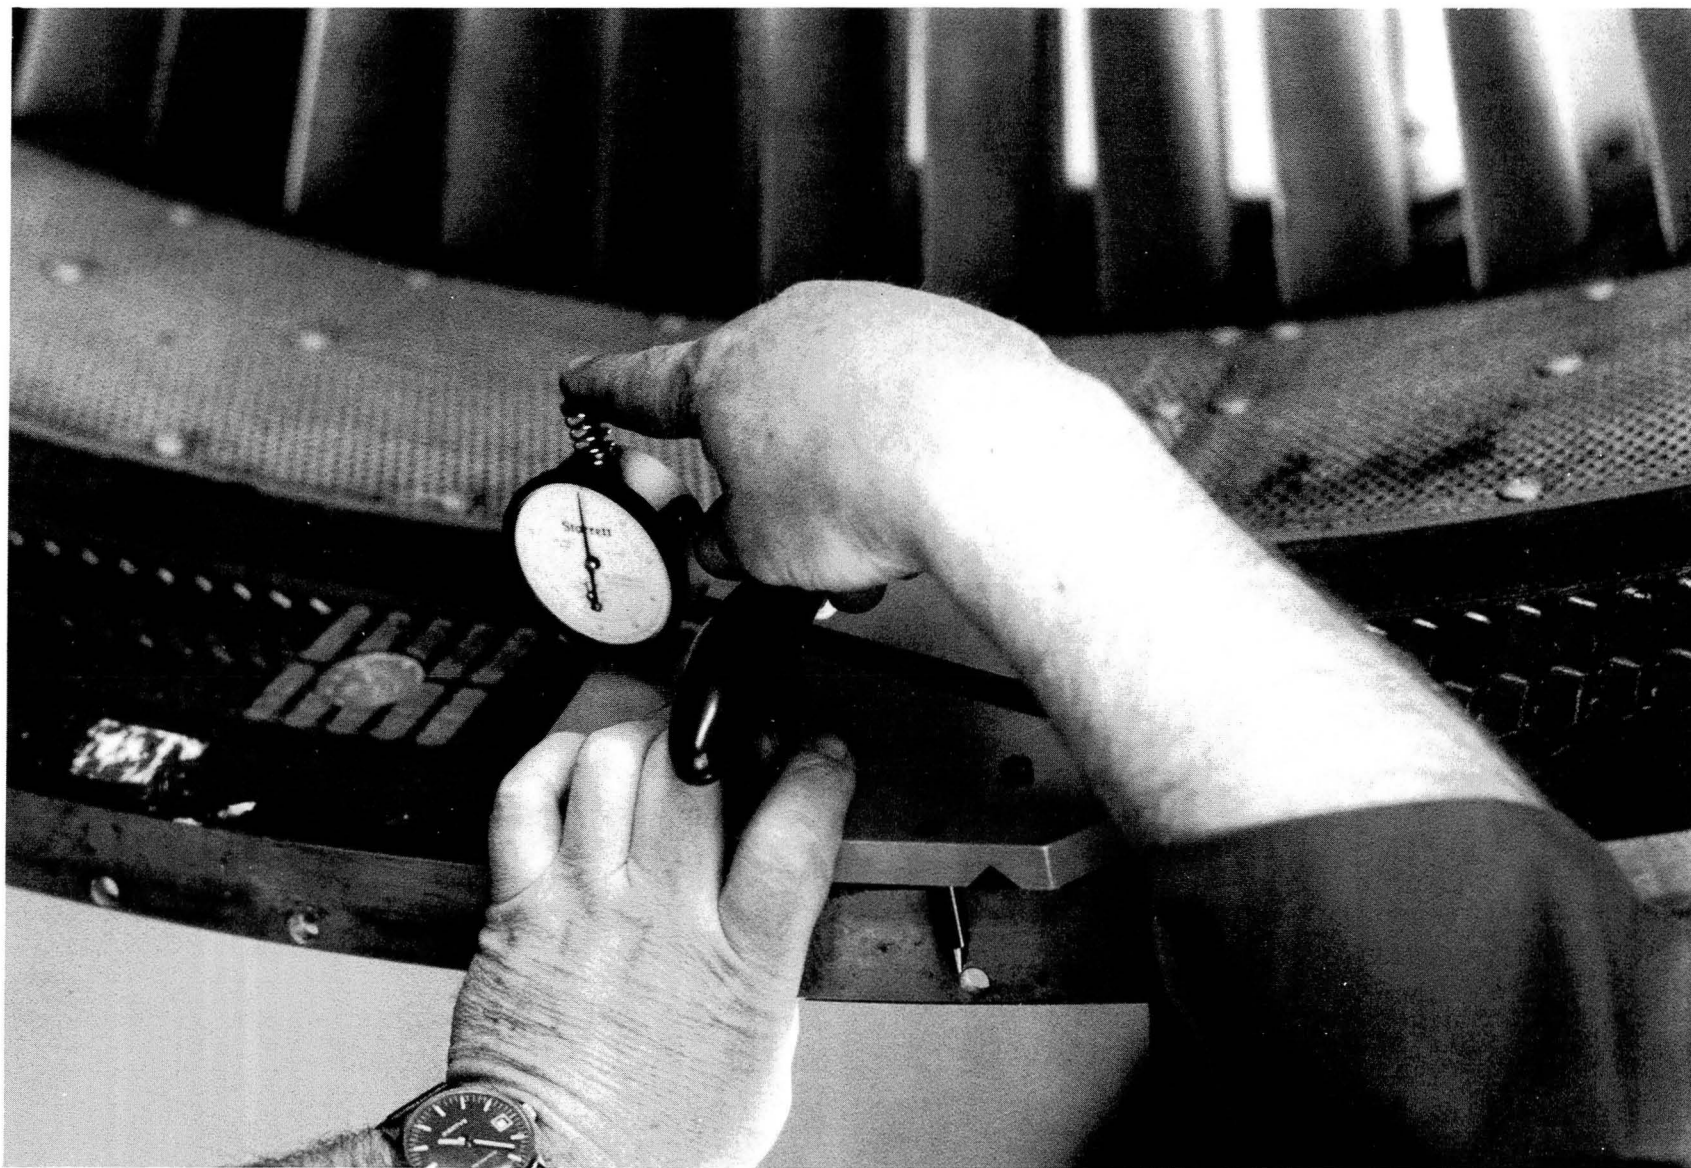
Fan Blade Rub Depth Measurement During Disassembly of Position 3 Engine.
(81C-153-30)
